Afghanistan STABILIZATION OF MILITARY AIRSTRIP

STABILIZATION OF MILITARY AIRSTRIP

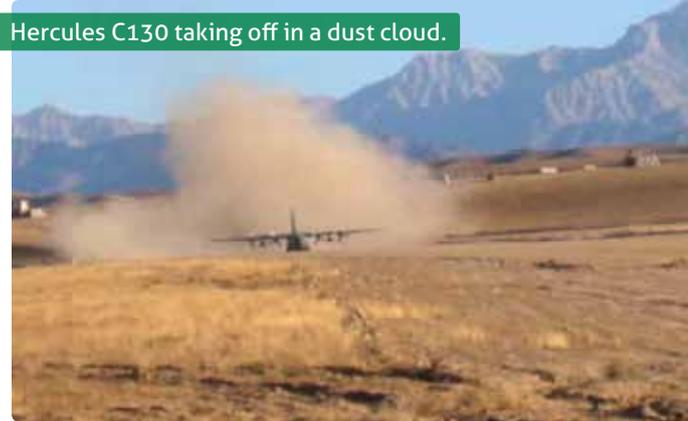
November 2005. A military base in Central Afghanistan was experiencing problems with their only one landing strip, used mainly for Hercules C130 supply aircrafts. During landings and takeoffs, a lot of dust raised up from the landing strip.

Problems were mainly due to the clayey nature of the soil. This factor made landing on the runway difficult and dangerous.

Hercules C130 taking off in a dust cloud.

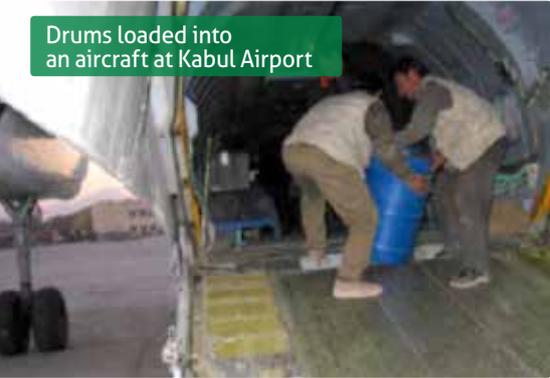
Drums loaded into an aircraft at Kabul Airport

Here is the technique we used to apply the product: the needed quantity was diluted in water and sprinkled on the airstrip by an aircraft driven by the local military troops.

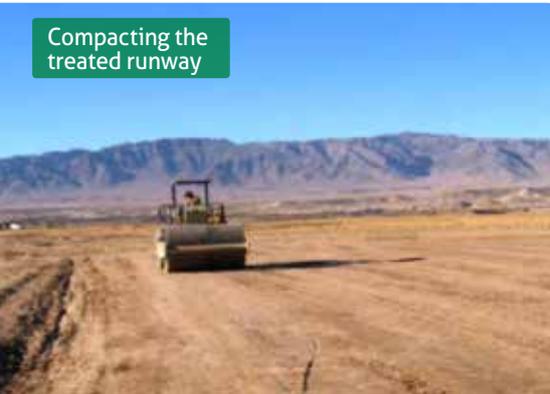
Compacting the treated runway

Finally, applying on the surface **TERRA PLUS** mixed with water, in low quantities and with frequent applications, proved to be the best solution. The process has been accomplished without causing much troubles to the scheduled landings and departures.

Shortly after completion, rains set in for three days non-stop, with the runway hardening and being solid enough for the planes to continue using the airstrip. The runway was then also compacted with a vibrating roller compactor in order to *leave the surface hard and dry.*

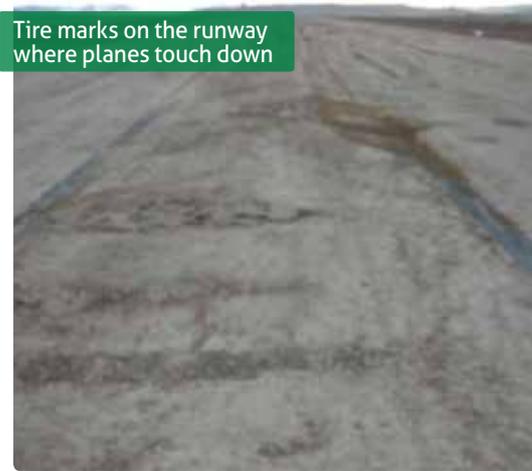
The landing stripe has stabilized now to such an extent, that the C130 planes leave rubber tire marks on the runway surface where the aircraft wheels touch down and make contact with the runway.

Tire marks on the runway where planes touch down

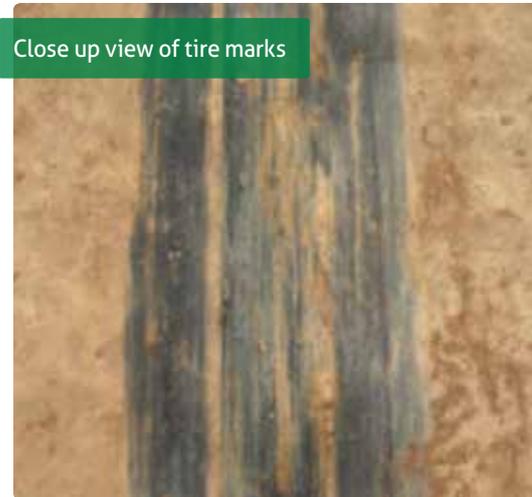
Close up view of tire marks
